MEMORANDUM FOR RECORD

SUBJECT: General Jenkins' House Site Visit

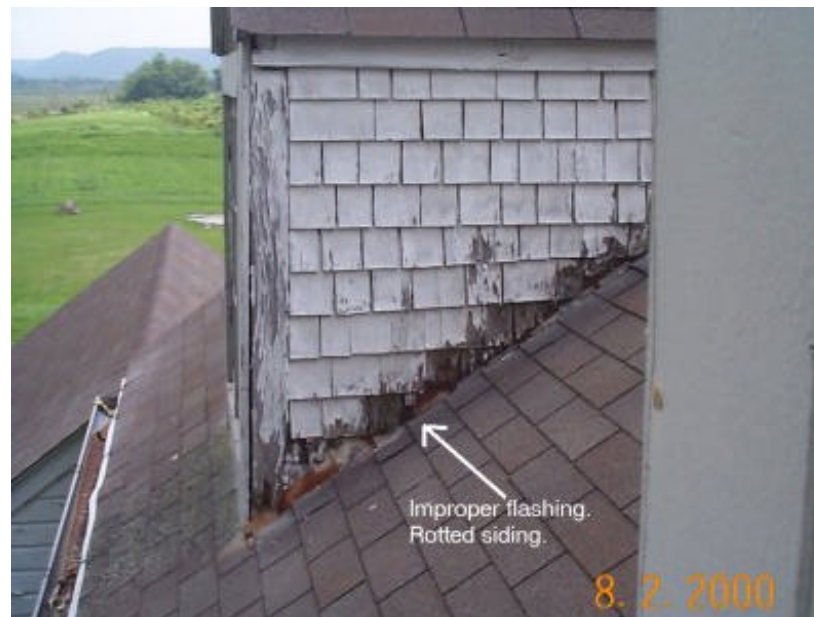
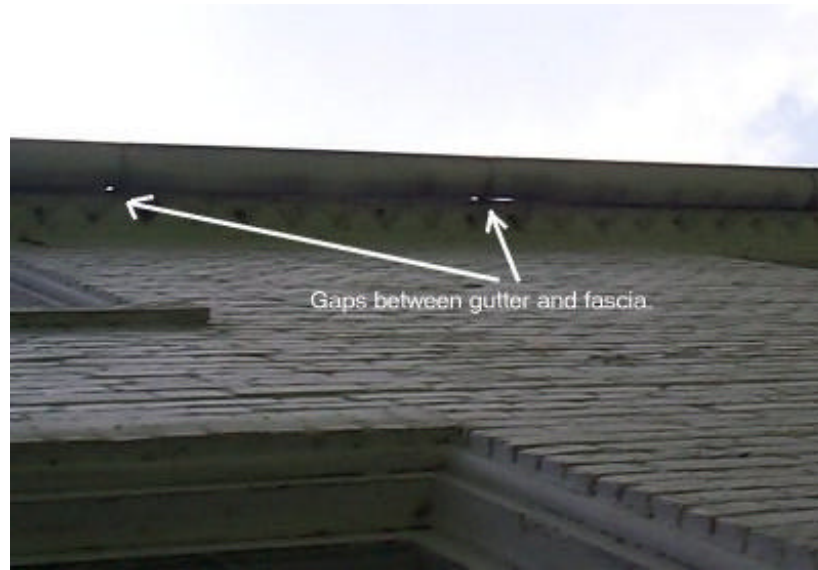
1. Structural Section employees Jason Merritt, Todd Mitchell, and Evan Dailey performed an inspection of the Historic General Albert Gallatin Jenkins' House on August 2, 2000. The building appears to be in good overall condition with no major structural concerns.
2. Water infiltration into the building shell seems to be the main issue. The following observations were made during the site visit (starting at the top of the house and working down):
  - a. Flashing around dormers and chimney is insufficient resulting in water infiltration into roof and walls. Siding on dormers is either rotten or missing all together causing further water infiltration. Flashing needs to be replaced at all valleys, wall, and chimney intersections. Siding and trim needs to be replaced on all dormer walls.

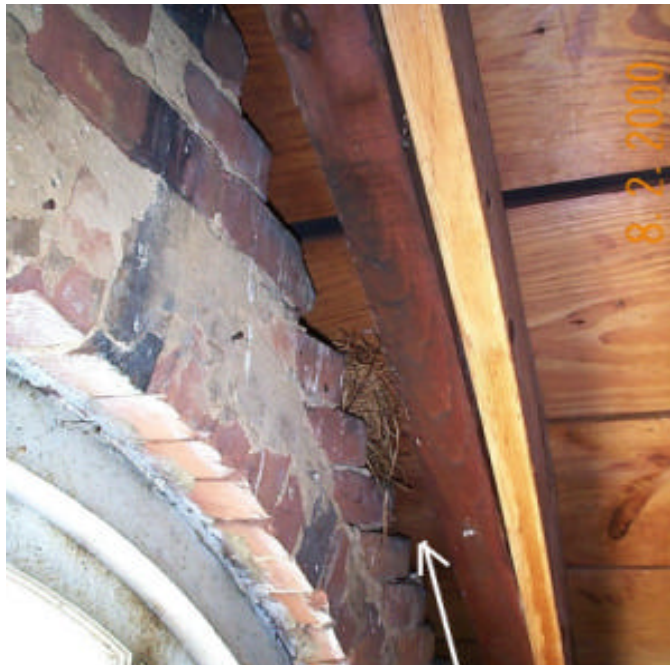
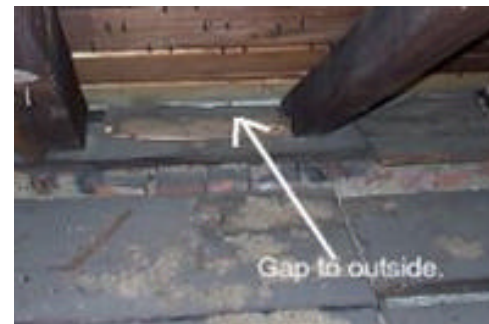
- d. Large gaps exist where the roof meets the gable ends and eaves allowing water, birds, etc. to enter the walls. Gaps need to be either filled or covered to prevent further damage.

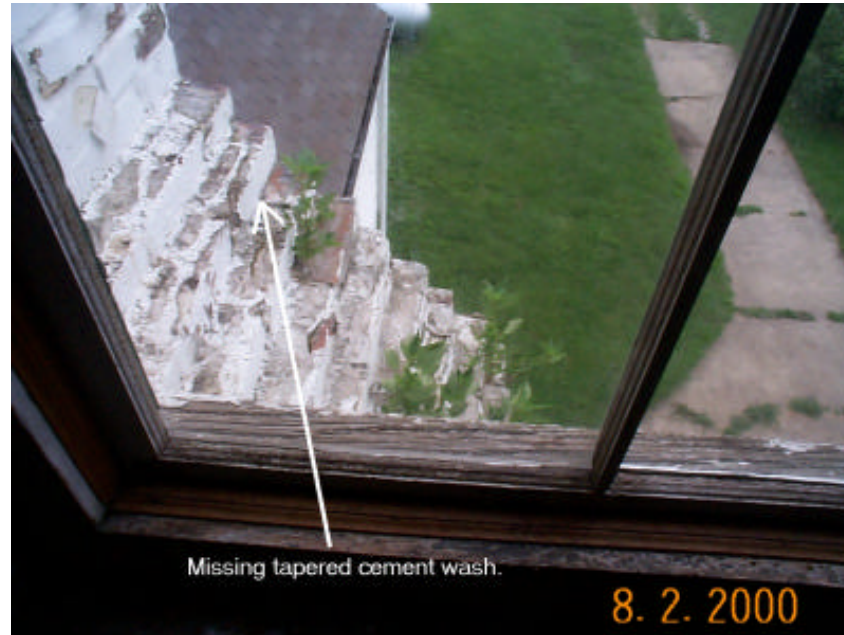
chimney, further contributing to the damage. Wash needs to be replaced to prevent further damage.

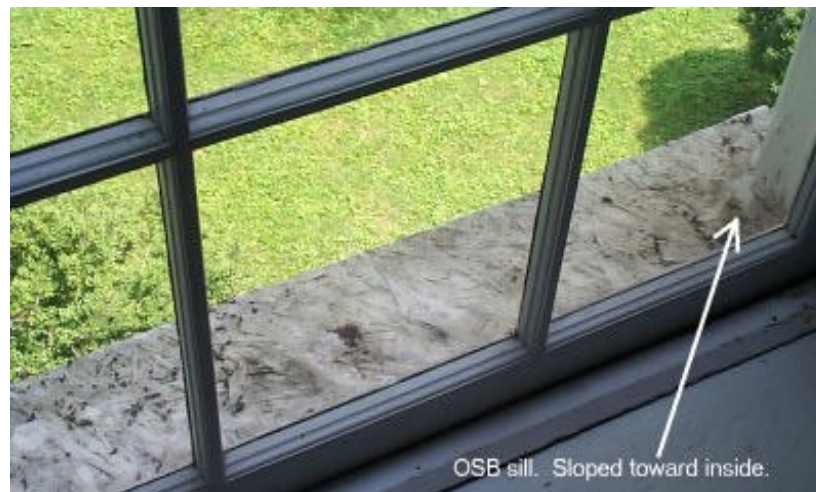
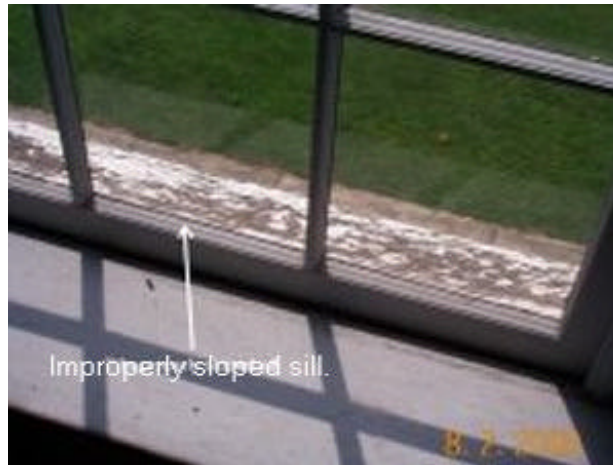
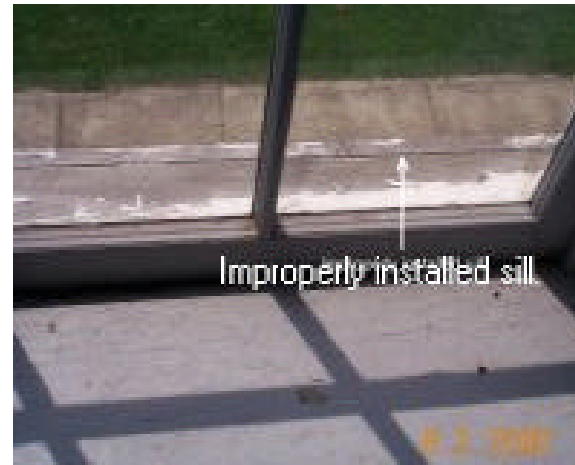
- f. Window sills on all floors are improperly installed and/or damaged. Most sills are sloped toward the window allowing water to penetrate the wall. Existing sills need to be removed and replaced with properly sloped and installed sills.

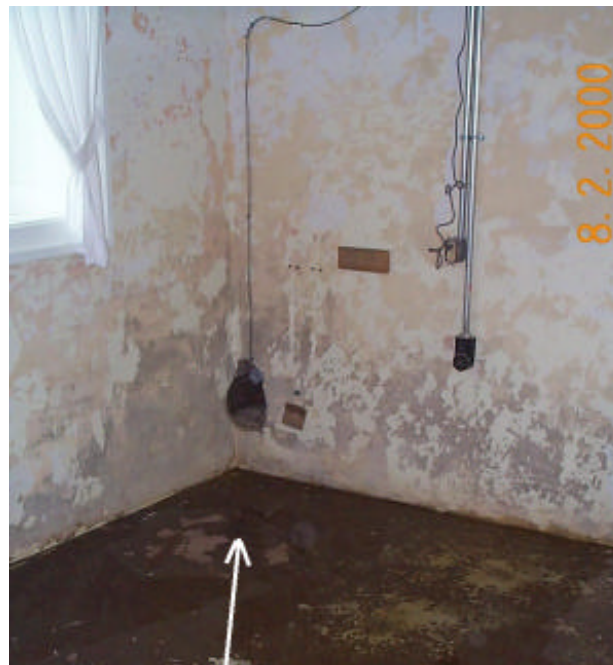
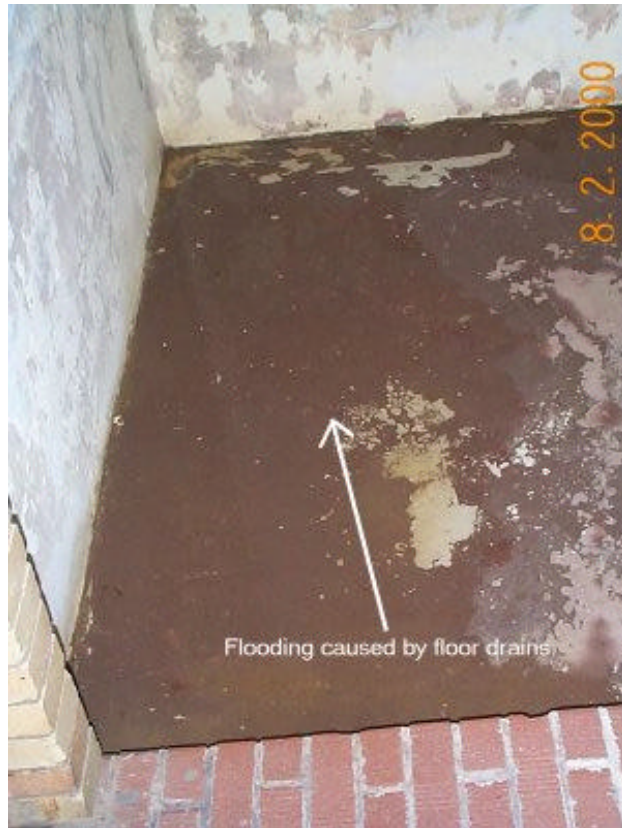
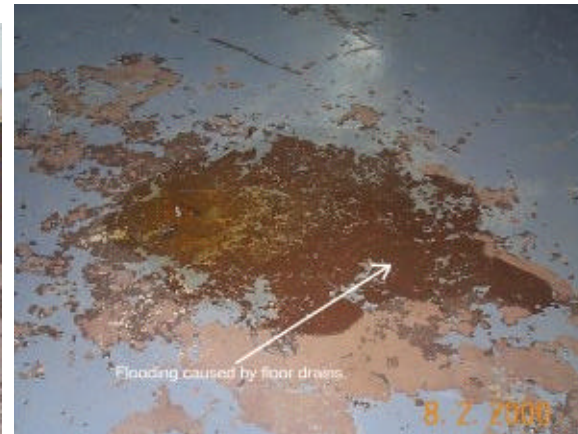
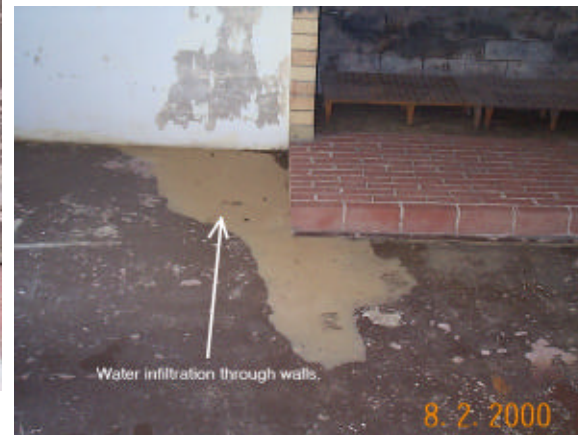
- g. Basement floor drains are apparently blocked or simply not connected to any drainage system. This is the single most significant problem with the structure. During periods of rain, water flows in the building through the floor drain outside of the basement door and has no place to go – thus flooding the basement. Floor drains need to be inspected and properly installed to remove all water that enters the building.

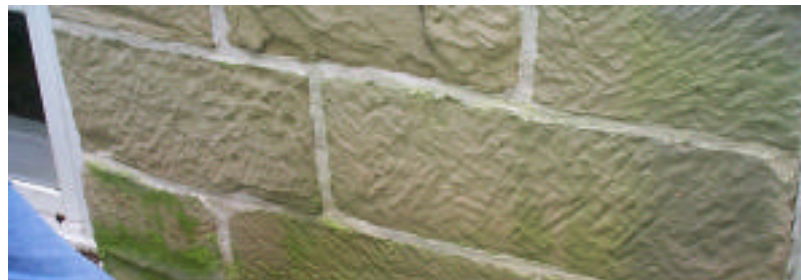
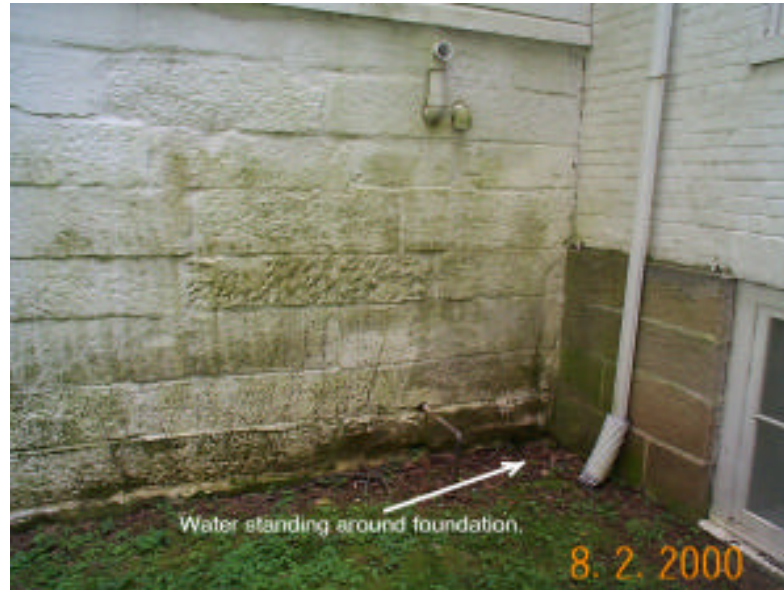
- h. Grade around building is improperly sloped – allowing water to stand around the foundation and seep in through the walls. Grade needs to be properly sloped away from the building to insure proper drainage.

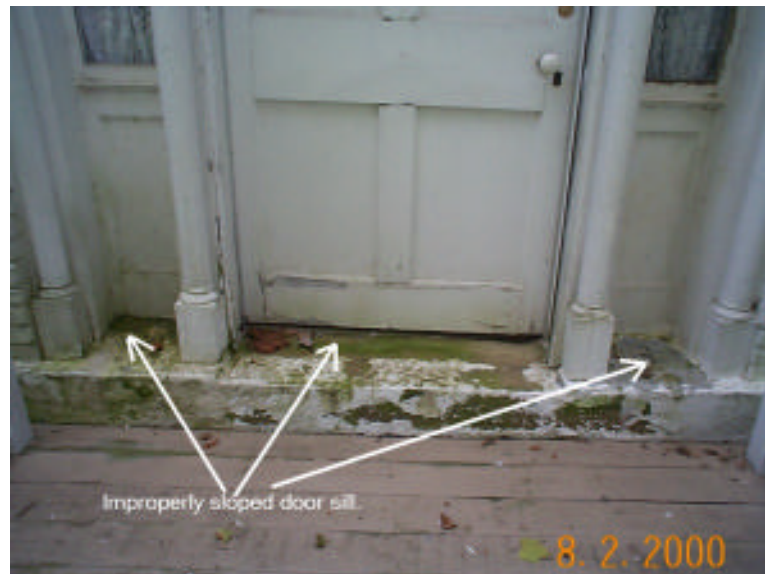
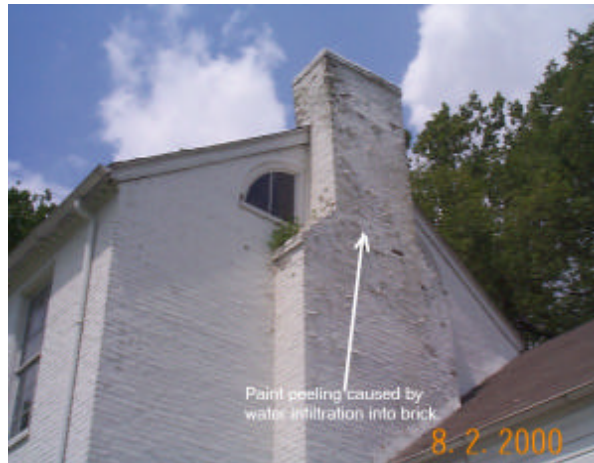
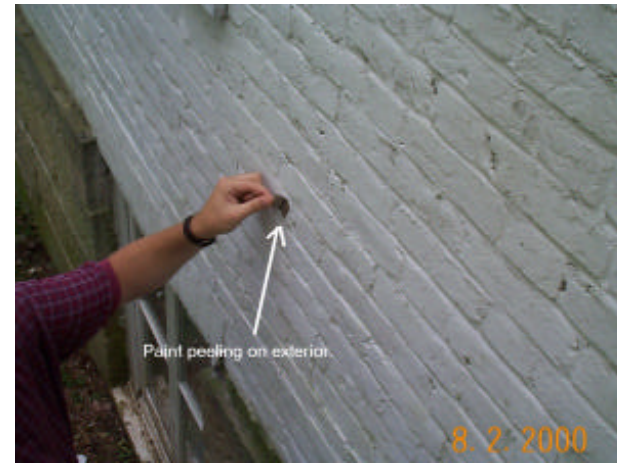
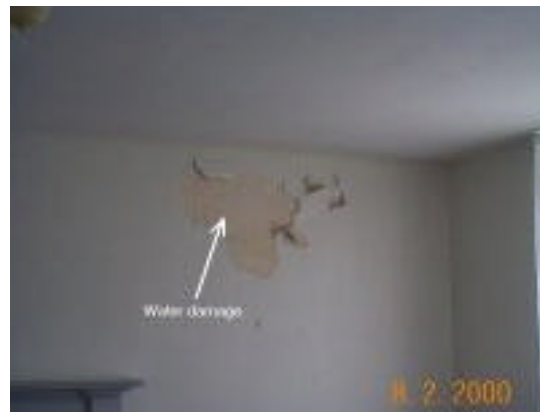
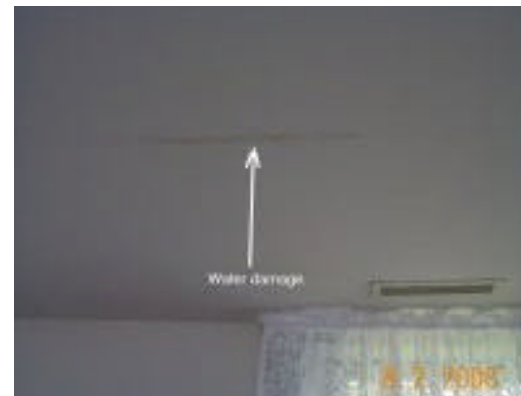
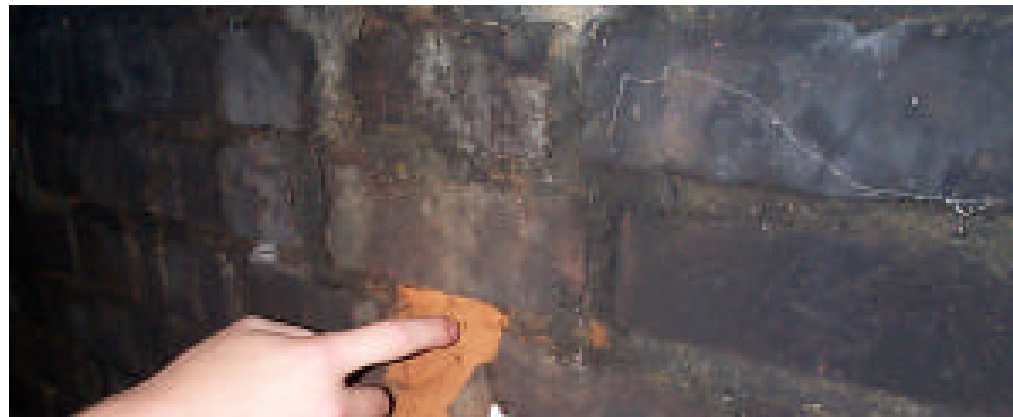
- i. The sill at rear door is improperly sloped and is allowing water to penetrate the building. Sill needs to be repaired to allow drainage away from the interior.
